# **USAAMRDL TECHNICAL REPORT 73-74**

## **EVALUATION OF VARIOUS SIZES AND CONFIGURATIONS OF FUEL TANKS**

**CONTRACT DAAJ02-71-C-0031**

**FIRESTONE COATED FABRICS COMPANY**

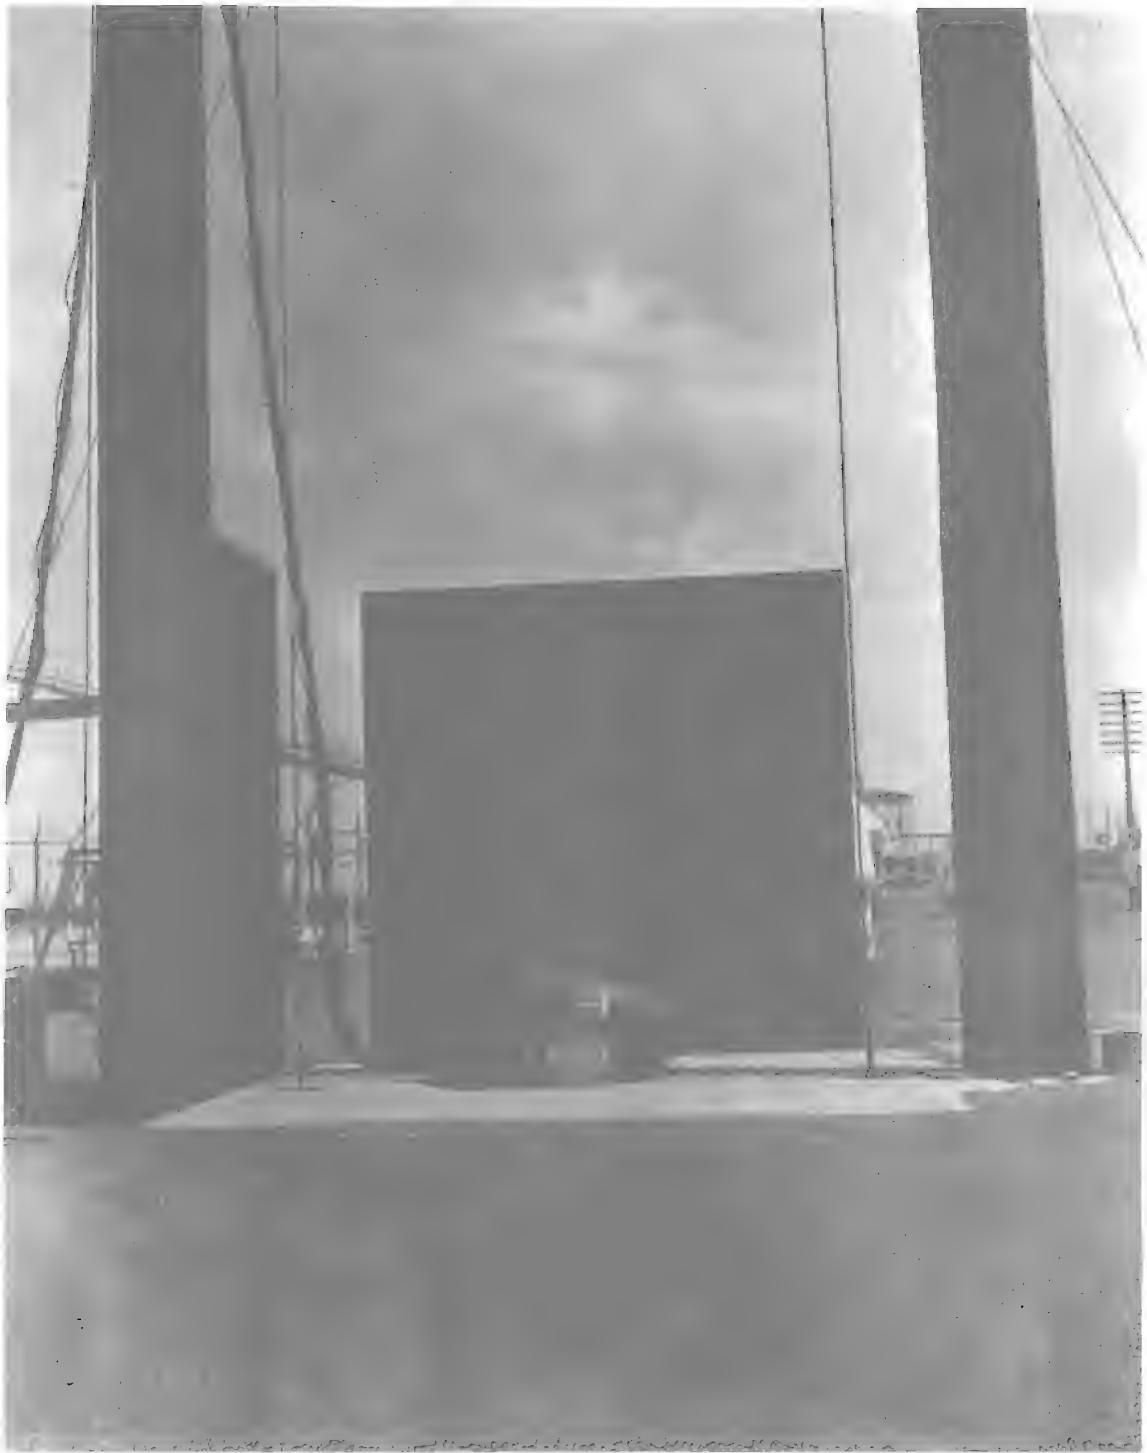
Figure 12. Impact of Procedure Check-Out Tank

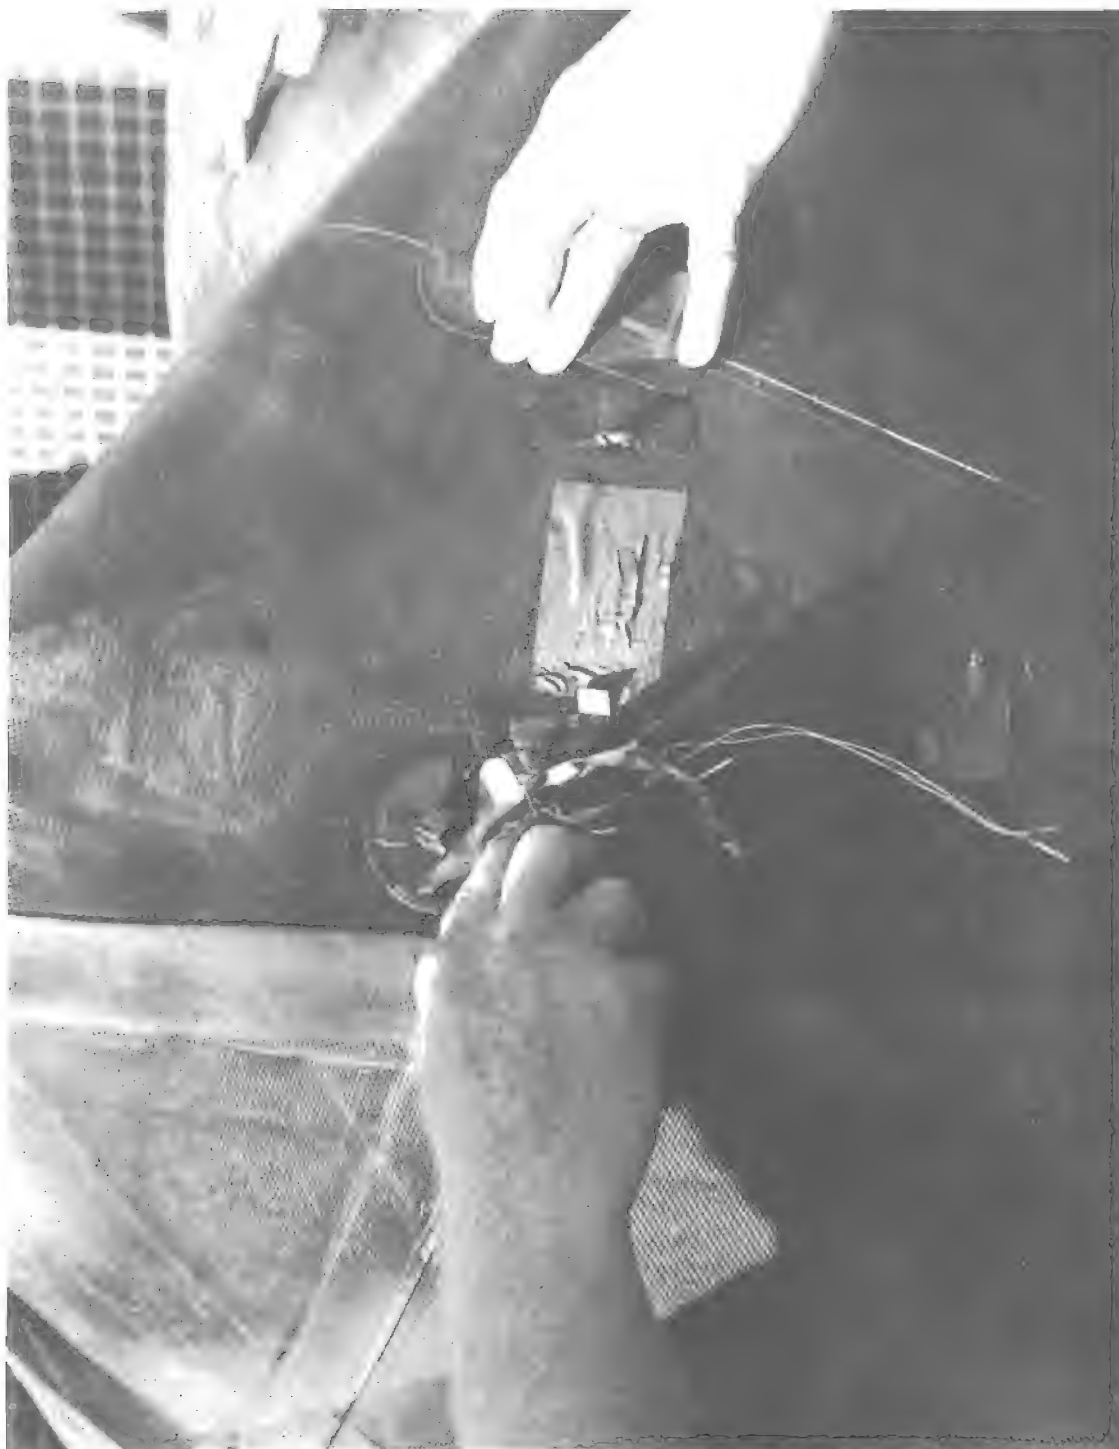
Separate special mounting pads at each end of the clip extensometers permitted individual mounting of each end of the extensometers and freedom of movement of the tank wall. Difficulties were encountered, however, in two areas with these extensometers. First, the inertia of the bowed metal projecting outward from the tank wall produced high bending moments at the mounting pad which frequently tore the extensometer from the pads during the contortions of the tank upon impact. Some of these were found as far as 50 feet from the tank. Attempts made to redesign and reinforce the mountings improved the condition, but never entirely corrected it.

Second, extensometers located near the tank impact face were trapped between the tank and the platform as the tank expanded upon impact. This not only obviously affected the measurement but also presented the possibility of tank damage to the point of failure since the sharp edge of the metal clip was frequently against the tank after being distorted. (See Figure 24.) In fact, one tank, Serial No. 57128, sustained a 2-inch cut through the inner liner, but did not tear. Leakage of water was minimal, and the tank successfully sealed as long as the wound was not misaligned. Photographs of the damaged tank as it came to rest are given in Figures 25 and 26. Because of the above difficulties, testing was suspended at that point until a more satisfactory strain gage could be devised.

Figure 24. Clip Damage During Impact.

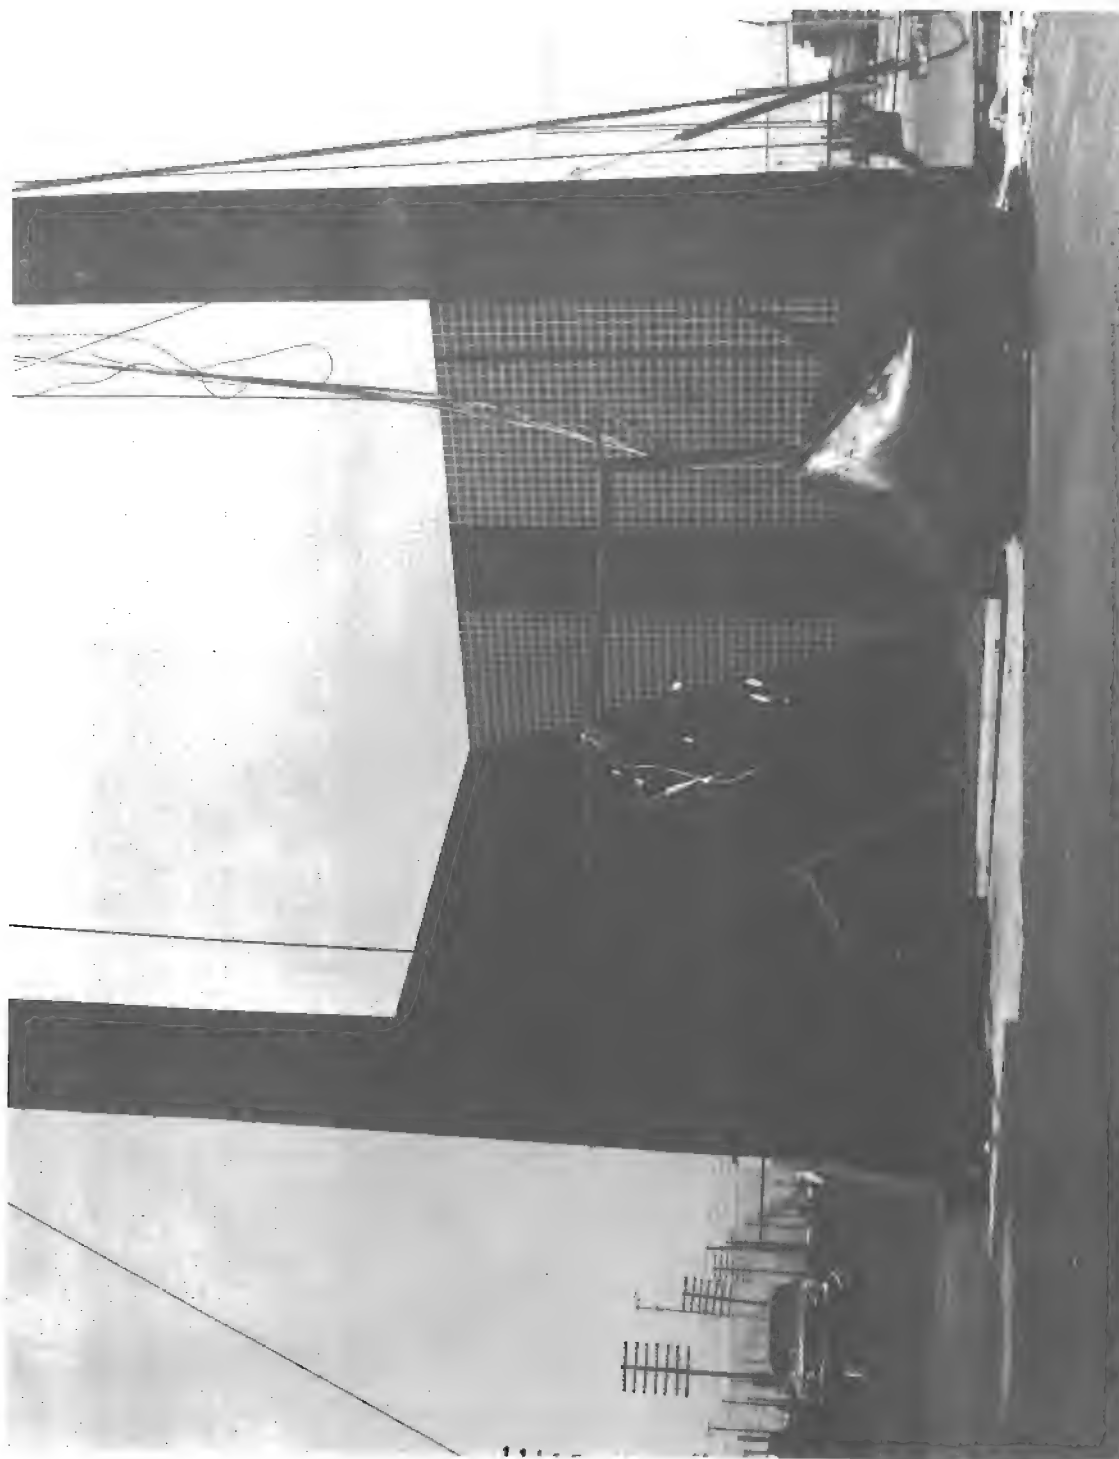
Figure 25. Tank Cut by Clip, Shown After Rebound.

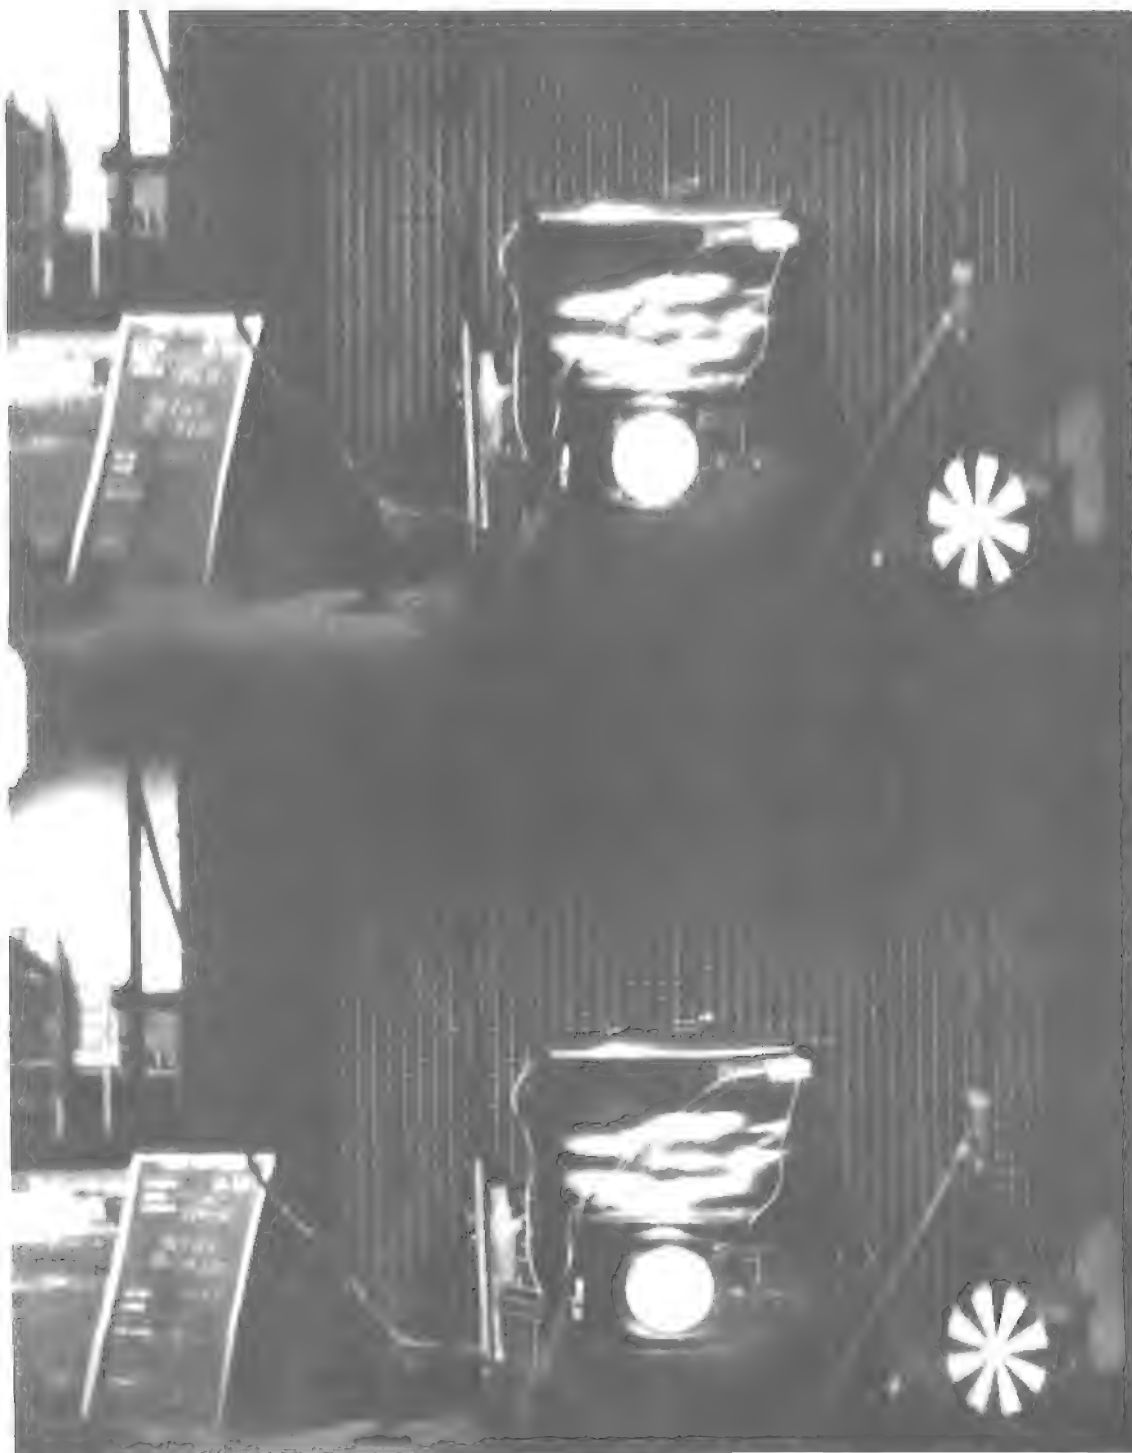
When the wave encounters a fitting, both horizontal elongation and vertical contraction are impeded. The fitting ring and cover plate effectively do not undergo deformation. The combination of panel plies and fitting flanges surrounding the ring, while flexible, is more restrictive than the tank wall. In consequence, the panel areas horizontally adjacent to the fitting are restricted from vertical contraction and cannot elongate to the same degree as panel areas above and below the fitting. The result is a high-tension area on each side of the fitting in which the tension diminished from the fitting horizontal centerline both upward and downward to the fitting flange areas above and below the fitting. The differential vertical contractions

between the panel areas horizontally adjacent to the fitting and those immediately above and below the fitting produce an excess or relative "looseness" of the cell wall/flange combination in these areas to the extent that horizontal wrinkles are produced. These wrinkles then permit the fitting to oscillate as the pressure wave passes. The presence of the wrinkles is shown in Figure 29.

1. High tensile forces are concentrated in the panel and flange areas adjacent to the fitting ring horizontally.
2. The restriction caused by the fitting effectively increases the modulus at the fitting elevation and consequently the pressure at that elevation, although the instrumentation was not sufficiently sophisticated to indicate this.
3. Multiple fittings, particularly at the same elevation, should exaggerate the increase in tension.

- D. Fittings in vertical walls produce localized areas of high tensile stress horizontally adjacent to the fittings.
- E. The only "hydraulic ram" of consequence is the ascending pressure wave.

Figure 29. Strain Pattern Adjacent to Fitting.
